SMC NEWS

July 2015 No. 007

Beihai, China: Delivery of MV "Stella Laura" - 180,000 DWT Bulk Carrier

Shipyard Always Knows Better – Cold Cracking on Hatch Coamings

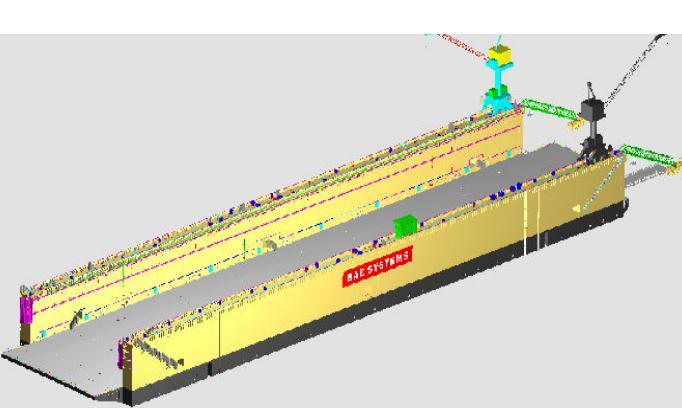
The dock is designed by HEGER USA, who specialize in design of dry docks, and consists of 3 pontoons with a lifting capacity 55,000 long ton. The dock will be fitted with 12 high capacity de-watering submerged electric pumps, which limit the total flooding time to 120 minutes and de-flooding time to 160 minutes at the designed lifting capacity. Two on-board generators provide a secondary source of power, with primary being shore power. Two wing wall cranes each with a maximum capacity of 50 tonnes cover the entire pontoon deck. The vessel handling system provided consists of 4 hauling winches and 4 centering winches (15 tonnes each) together with 16 single swivel directional sheave blocks.

A control house provided on the starboard side wing deck serves as a centralized station to control and monitor critical equipment such as Diesel generators, de-watering pumps, remote tank readings, shore power, ICCP, fire main, compressed air and alarms.

Length over pontoons	259.7	m
Length over all	289.7	m
Width between outer wing shells, molded	62.4	m
Width between inner wing shells, molded	51.60	m
Overall depth (steel hull at outside of wing wall)	22.37	m
Maximum design draft	19.76	m
Rated lift capacity	55,000	long tons

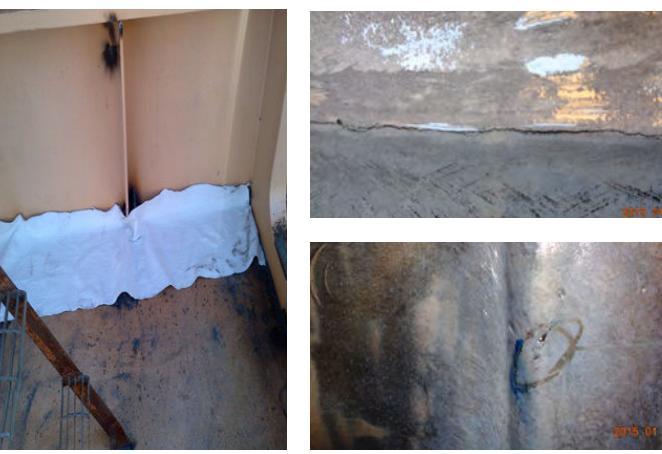
poor post heating

cracks

During the final inspection, after welding, we found a single crack. Fillet welding was discovered between longitudinal hatch coaming and main deck. Our investigation extended very fast, to not only welding of longitudinal hatch coamings but welding of hatch coaming top. More and more cracks were found, MT on each one from 5 cargo holds. Due to different construction, the biggest problems occurred on cargo holds No.2 to No.5, and most of them were on longitudinal parts.

After careful analysis of positions and profiles of occurred cracks, we agreed that the cracks found on welds belong to hydrogen cracking.

If the cooling rates associating with welding is too rapid, excessive hardening can occur in the heat affected zone. If sufficient hydrogen is present in the weld, the hardened zone can crack spontaneously under the influence of residual stress after the weld cooling down to near ambient temperature.

The safe preheating temperature to be used should be above 110 °C. The preheating temperature should be measured at a distance of minimum 75 mm from edge of the groove at the opposite side of the heating source when practically possible.

When there is a higher risk of cold cracking, hydrogen release should be accelerated by either maintaining the minimum interpass temperature or raising the temperature to 200 °C to 300 °C, immediately after welding but before the weld region cooling down to below the minimum interpass temperature. The duration of post-heating should be at least 2 hours and is a function of the thickness. Larger thicknesses require temperatures at the upper end of the stated range as well as prolonged post-heating time. Post-heating is also appropriate when a partially filled weld cross-section is to be cooled.

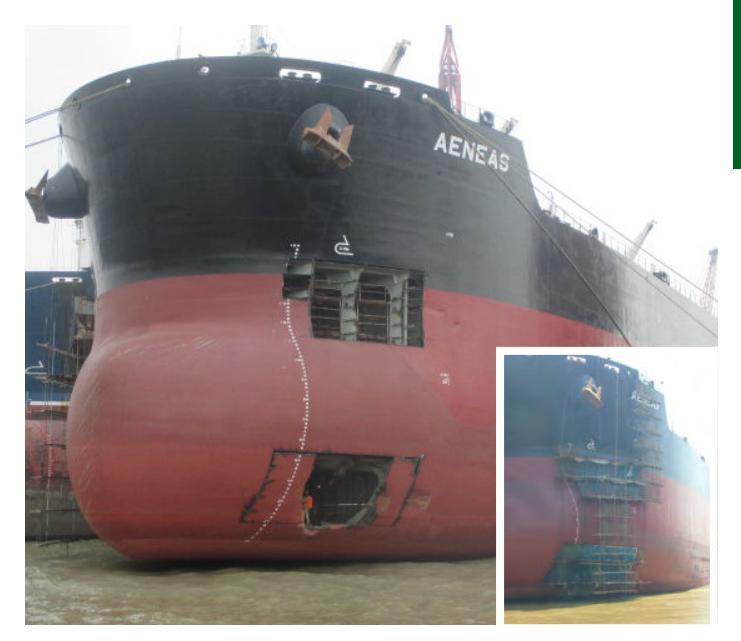
MV "Aeneas" was undergone a collision with another container vessel at Shanghai pilotage on 2 April. The vessel's bow part (port side) was heavily damaged. After preliminary damage assessment at Shanghai, the vessel was brought to COSCO Nantong Shipyard for the repair work. SMC was asked to do the repair work assessment and the entire repair work supervision at the Yard. Since no floating dock was available at the Yard during that time and due to the urgency in carrying out the repair work, it was decided to carry out floating repair work with trimming the vessel by aft. The repair assessment was carried out by SMC supervisors and DNV GL surveyors, and the repair plan was finalized and accepted by the Class Society. Damage occurred on shell plate, web frames and stringers in way of fore peak tank, void space and No.1 cargo hold (port). The vessel was Korean built, hence the lines plan for the hull form was not readily available and offsets for the double curvature shell plate was taken from the non-damaged starboard side shell plate using hanging platforms.

New shell plates were cut and formed and internal members were fabricated and the repair work was carried out successfully and timely by using a combination of hanging platform, floating crane and barge. All the NDT work (UT and RT) and air test were carried successfully and handed over to painting department for the coating work. Work was ongoing in two shifts 24 hours during the last one week.

The repair work was completed on 28 April and the vessel sailed out on 29 April. The total steel weight renewed was estimated as approximate 57 tons.
